## Field Safety Notice / FSCA 001-23

We would like to share with you, and your team, information about an issue that could be observed on the blood grouping analyzer **IH-1000 software version 04.08.11** intended to be used with the Data Management Software IH-Com version 5.2.5 Service Pack.

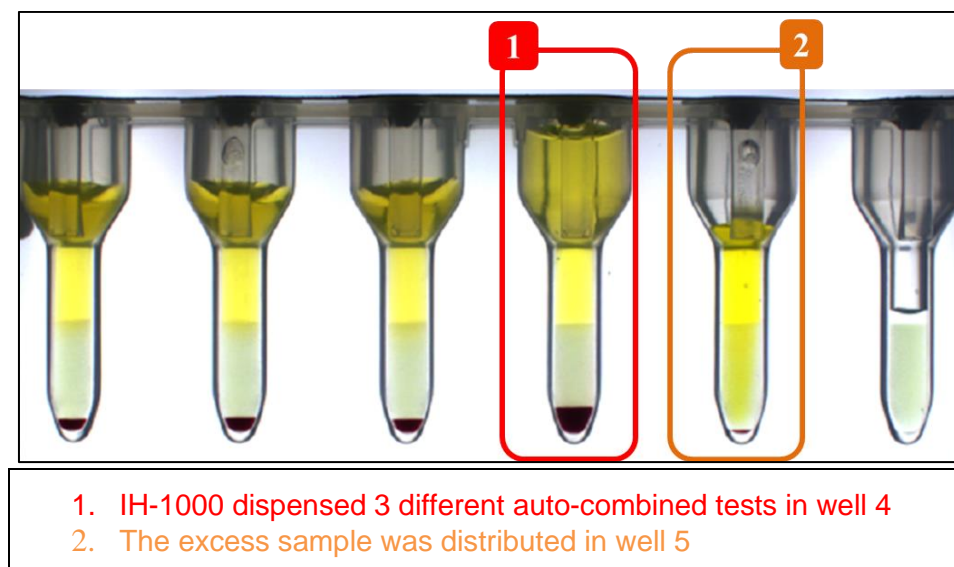
When these conditions are fulfilled, separate tests (requested by IH-Com) will be treated as auto-combined tests (execution of PR80D / PR80E / PR80F / PR80H / PY80D) by IH-1000 and samples from the same patient and different donors might be incorrectly dispensed in the same well instead of separated wells (see example in Figure 1).

Once the tests are processed, the IH-Com displays the same well for all crossmatch results.

**Figure 1\_Example of misdistribution of the auto-combined test**

- 1) Access the IH-1000 Options Menu and, on the “Control” tab, enable the “return of gel cards to drawer for second reading” function selecting the “Customized” option (Refer to IH-1000 User Manual Section 8.4 and 6.1.4 c)

This will prevent the inappropriate execution of an auto-combined test. The gel cards will be put returned to positions 4, 5, 9, 10, 13, 14,15, 18, 19, 20 of the drawer. Make sure that these positions are available and with empty card trays. To ensure a proper identification of the empty trays, use the white trays (REF 009888) for the cards returned to the drawer.

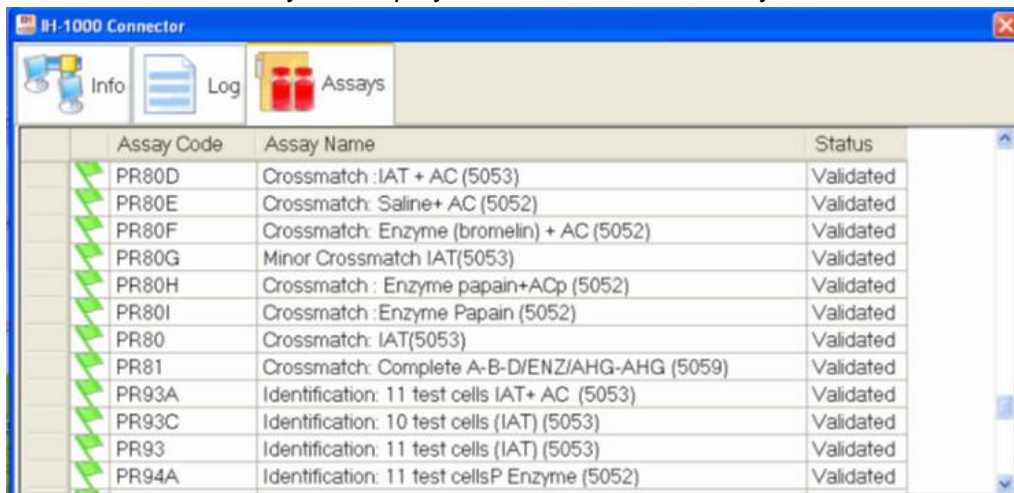
- Check if any of the test codes provided in table 1 is listed with the status Validated.
