Carl Zeiss Suzhou Co., Ltd.

Our Ref. : FSCA -SHS-2023-001

FIELD SAFETY NOTICE

FSCA- SHS-2023-001, OPMI LUMERA 300, inspect (repair if needed) the suspension arm

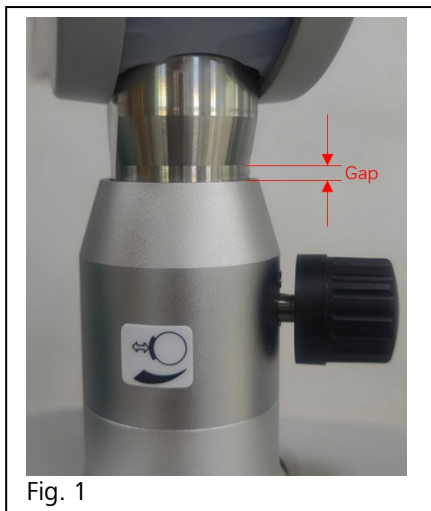
In certain devices there is a probability of specific screw missing during assembly. This screw is used to prevent one internal thread cap rotating which ensure the connection between suspension arm and the suspended components. The identified defect may lead to a potential risk.

arm may cause the suspended components fall from the suspension arm, it may lead to a potential injury to the person under the suspended components.

The gap shown in Fig 1 indicates the fasten status of thread cap (not visible) which carries all load of suspension arm. If this gap is not in its nominal value, there is a risk of OPMI falls from suspension arm.

- Measure the gap shown in Fig. 1
If the gap is greater than 5mm, **please Immediately stop using the device!**
In this case the OPMI LUMERA 300 can no longer be used.

We are planning to inspect (repair if needed) of the suspension arm immediately. Our service staff will contact you to arrange an appointment for inspection (repair if needed) of the suspension arm. Please do not hesitate to contact your local ZEISS organization in case of any concern or question.
