Title	Calisto Gantry Cover Bracket Inspection and Replacement
-------	--

Field Action

RXFA23-008, Rev A

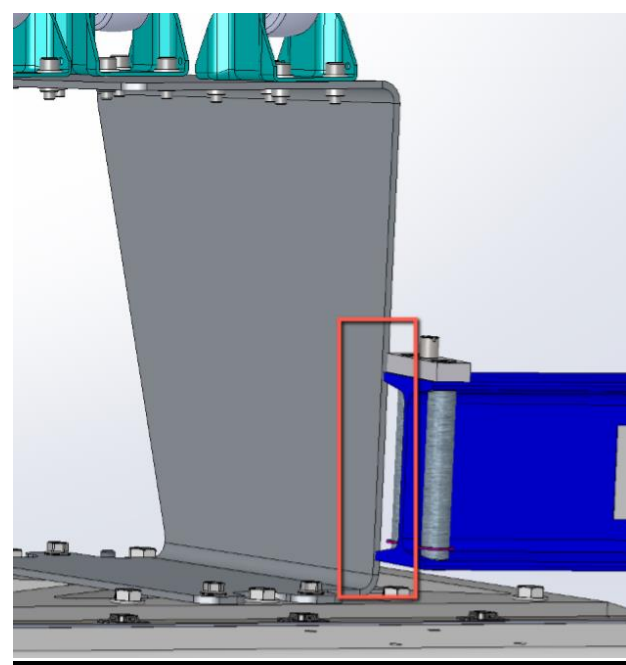
It has been discovered that when utilizing the Jib Crane Assembly while servicing Radixact systems with a Calisto style gantry, that in some instances there is not enough clearance for the Jib Crane to function as intended. In these instances, it will collide with the cover bracket at the top of the gantry. When this occurs, the Field Service Engineer may try to lift the Jib Crane to clear the bracket, which creates an unsafe working condition and presents a safety hazard to the Field Service Engineer.

6. Travel onsite and perform the Field Action.
7. Remove the gantry covers and inspect the Jib Crane and observe that the Jib Crane can move past the cover bracket at the top of the gantry without interference, as shown below.

8. If the Jib Crane does collide with the bracket, then order PN 1088370 - FRU, Enclosure, Gantry, Upper Roller Bracket, Radixact, Gen2.
9. Once the item has been received, replace it by downloading T-SVC-01348 – Upgrade the Radixact Gantry Enclosure Upper Bracket from Agile and replace the bracket.
10. Restore the system to functionality.
11. Close the work order in ServiceMax once the work has been completed. Please ensure that the signed Customer Notification from Step 3 is attached to the work order prior to work order closure.
