URGENT IMPORTANT FIELD SAFETY MODIFICATION

Subject: Oncentra® Brachy v4.5.4 and 4.6.2 Installation Instructions

Product: Oncentra® External Beam Oncentra® Brachy

Description of Problem:

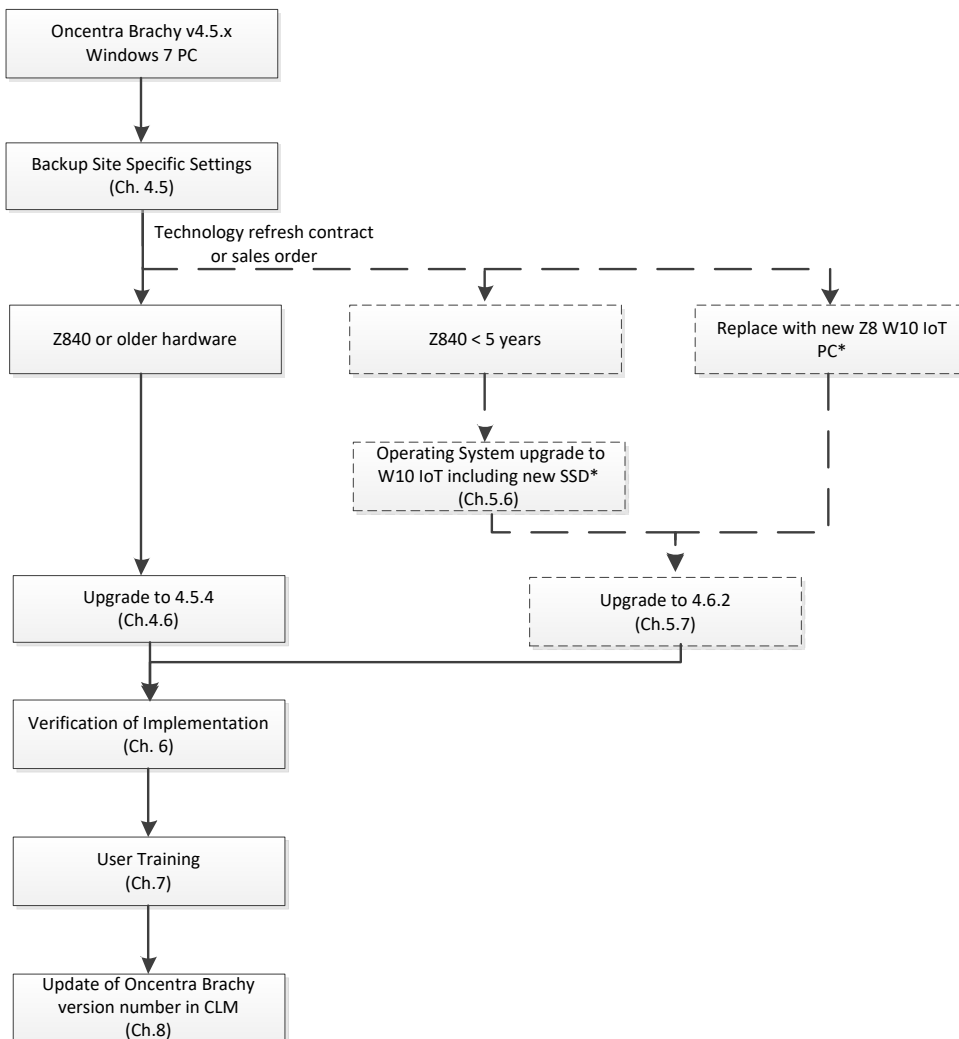
Below diagram explains which steps to take to upgrade the systems. In solid lines you see the direct upgrade path to Oncentra Brachy v4.5.4.

The dashed lines show the possible upgrade paths to the latest Oncentra Brachy 4.6.2 version. The costs of new hardware, operating system, software upgrade(s) (indicated with a * in the diagram) and possible training are part of a service contract including technology refresh. In case a customer has no service contract, or a service contract without technology refresh, contact your local service or sales representative for support.

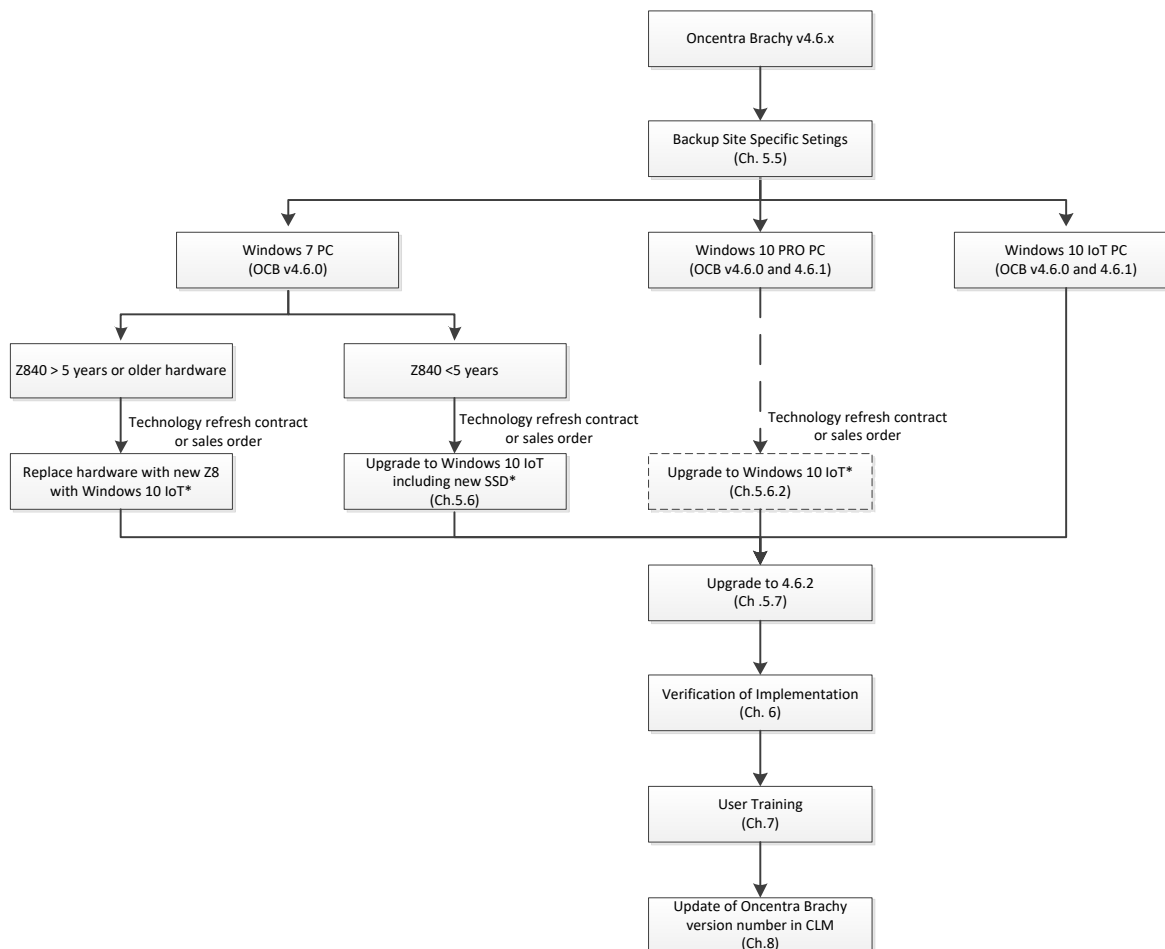
Below diagram explains which steps to take depending on the hardware. In solid lines you see the direct upgrade paths. The dashed lines show the possible upgrade paths to the latest Windows 10 IoT Enterprise 2019 LTSC platform. In the rest of this document Windows 10 IoT is used for readability.

The cost of new hardware, operating system or software upgrade(s) (indicated with a * in the diagram) are part of a service contract including technology refresh. In case a customer has no service contract, or a service contract without technology refresh contact your local service or sales representative for support.

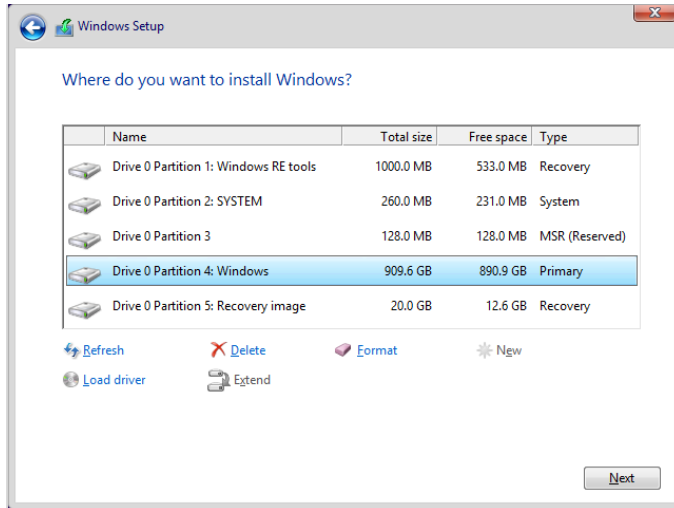
See picture below as an example. In this case the C drive is actually Drive 0, but this could also be Drive 1 or 2.

13. Select the C-drive, in the overview the C-drive might not be disk 0, so make sure to select the drive with Windows on it. Delete all existing partitions on the C-drive via the delete button, until there is 1 drive with only Unallocated Space left, select **Next**.
