## Updated Field Safety Notice

MR systems with SW versions R11.1 and R12.1  
MobiView cross reference alignment errors

May 2026

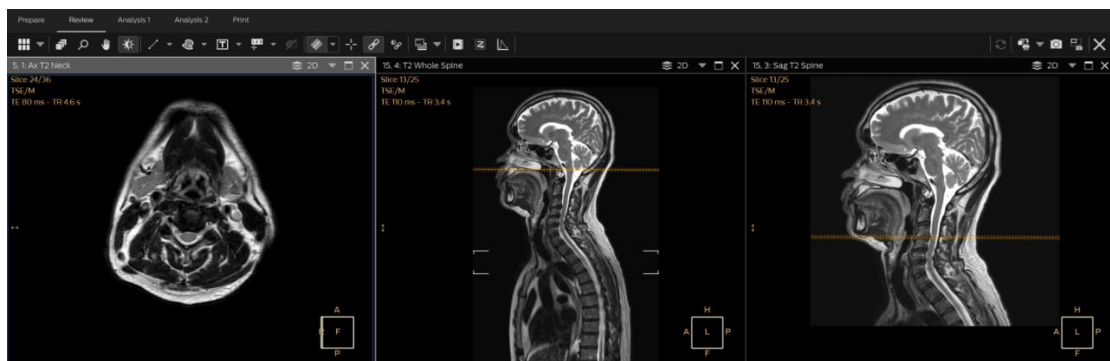
- A. The cross reference line and/or box may be shown at an incorrect location when displayed on a MobiView generated image (see examples in Figure 1 and 2).

- Multi-station scans that require stitching 3 or more station images, and
- Scan protocol is used where stations have different voxel size or field of view (i.e. voxel size or field of view is customized based on anatomy per station).

Figure 1. Cross reference line of the axial image (left) is at the incorrect location on the MobiView generated image (middle). The correct location is shown on the non-fused sagittal source image (right).

There is a potential for misdiagnosis if the cross reference information from MobiView generated images is shown at an incorrect location.

- You may continue to use your system(s) in accordance with the intended use.
  - A. To avoid the potential issue of an incorrect cross reference line in MobiView generated images, use the same voxel size and field of view across all station scans.
  - B. Do not use cross reference line functionality in box mode, all slices mode, or 3D mode. Use the cross reference line functionality in single slice mode.
- Circulate this notice to all users of this device so that they are aware of the issues and associated hazard/harm.
- Please retain this Field Safety Notice with your system(s) until the software upgrade is installed; ensure the notice is in a place likely to be seen/viewed.

A Philips representative will contact you to schedule time for a Field Service Engineer (FSE) to install a software upgrade to resolve the issues (reference FCO78100585, FCO78100620).

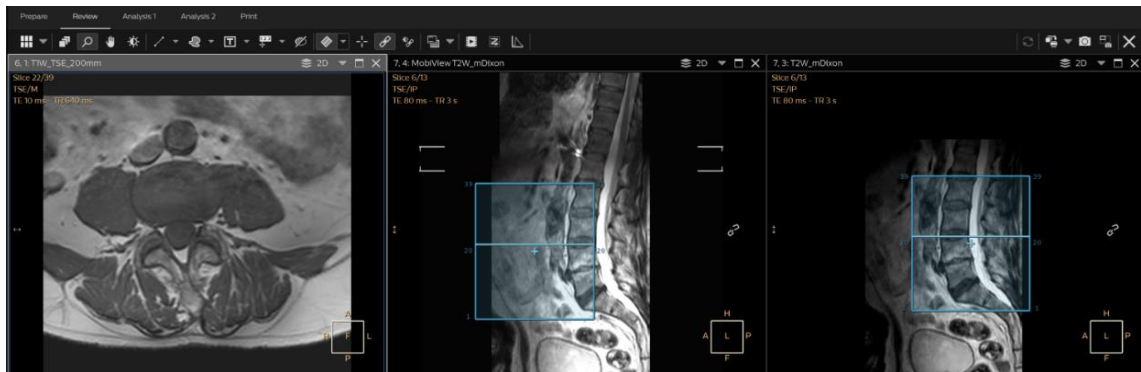
Figure 2. Cross reference box of the axial image (left) is at the incorrect location on the MobiView generated image (middle). The slice position in the box is correct, while the box off-center is incorrect. The correct location is shown on the non-fused sagittal source image (right).

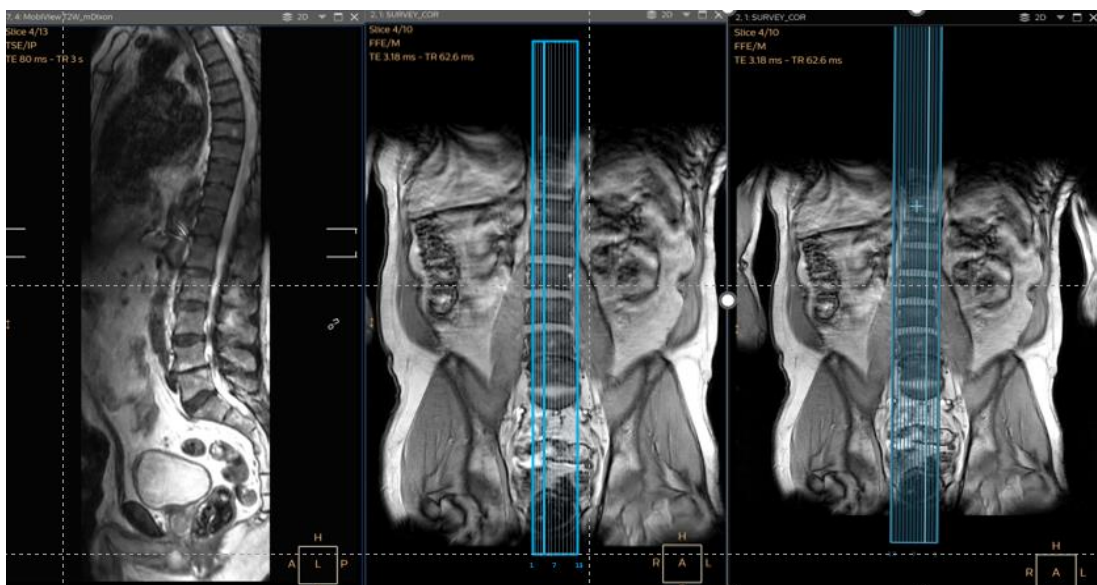
- B. The cross reference box of a MobiView generated image may be shown at an incorrect location when mirrored on to another image (see examples in Figures 3 and 4), if:
- the MobiView images are acquired with reversed slice scan order (i.e. image display settings are customized), or
  - displaying the cross reference box of a MobiView generated merged series (axial stations), or
  - displaying the cross reference box of multi-planar reformats generated from multi-stack data.

Figure 3. Cross reference box of a MobiView generated image with reversed slice scan order (left) is mirrored on another image (middle). The box position is correct, while the slice position and slice numbering are incorrect. The correct location is shown for a MobiView generated image with default slice scan order (right).

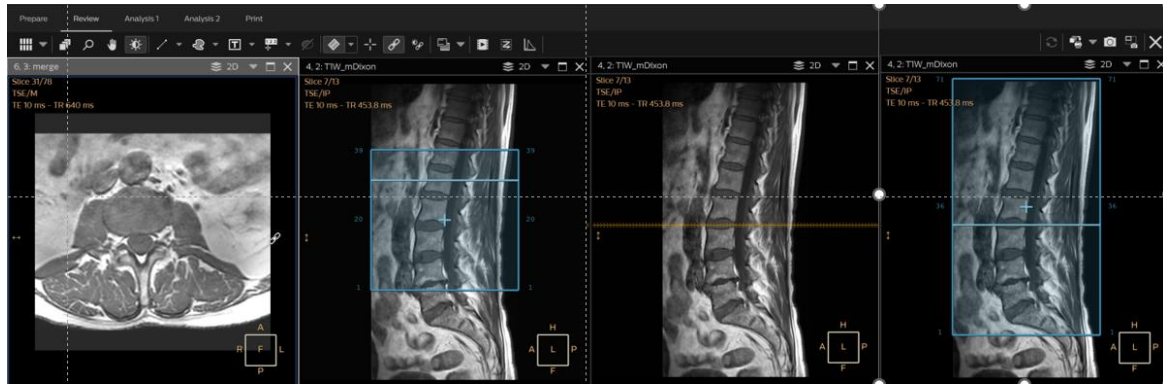
Figure 4. Cross-reference box of a MobiView generated axial merged series (left) displays with incorrect size and location on another scan (mid-left). The cross-reference line of the same MobiView generated axial merged series is at the correct location (mid-right). The correct box size and location is shown for a Mobiview generated axial fused series (right).
