Carl Zeiss Suzhou Co., Ltd.

Our Ref. : FSCA -SHS-2023-001

FIELD SAFETY NOTICE

FSCA- SHS-2023-001, OPMI LUMERA 300, inspect (repair if needed) the suspension arm

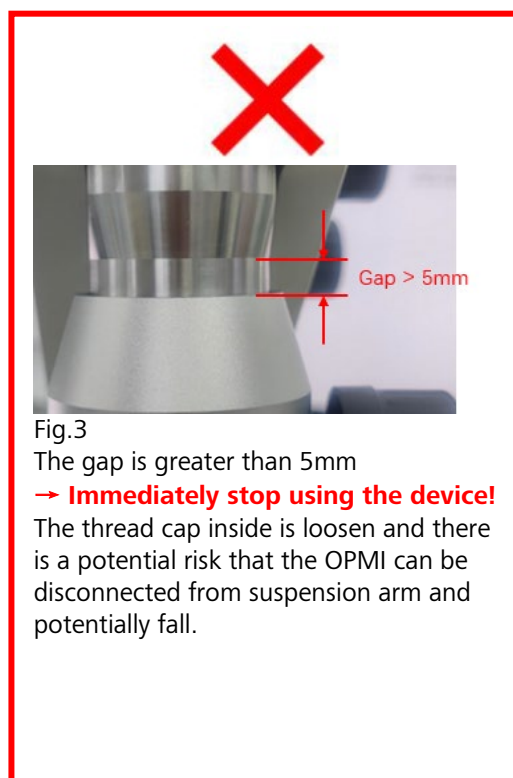
The gap shown in Fig 1 indicates the fasten status of thread cap (not visible) which carries all load of suspension arm. If this gap is not in its nominal value, there is a risk of OPMI falls from suspension arm.

- Measure the gap shown in Fig. 1
If the gap is greater than 5mm, **please Immediately stop using the device!**
In this case the OPMI LUMERA 300 can no longer be used.

We are planning to inspect (repair if needed) of the suspension arm immediately. Our service staff will contact you to arrange an appointment for inspection (repair if needed) of the suspension arm. Please do not hesitate to contact your local ZEISS organization in case of any concern or question.
